Condensate Tank, UAE

POLYUREA

| Project Area | Condensate Tank, Sharjah Tank base and first course shell Diameter 21m |

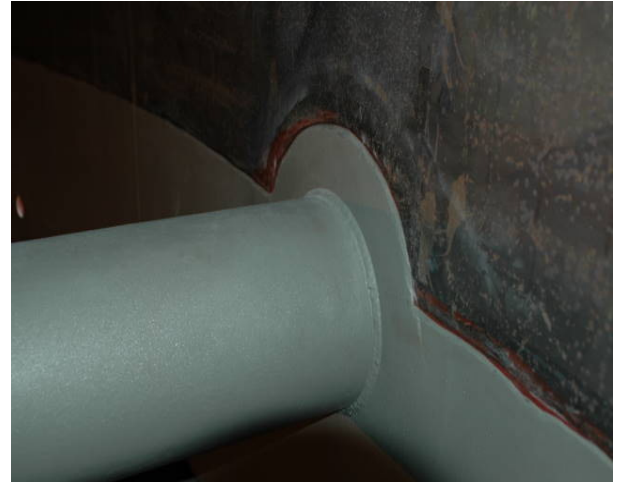
The condensate tank base had lost its integrity, corrosion has damaged the floor due to water forming under the condensate, and being in direct contact with the steel, once the epoxy paint lining was damaged.

1. Corroded steel tank base and 1st course shell were grit blasted to SA 2.5 cleanliness and to a minimum 75µm profile.
2. A Zink Primer was spray applied to the blasted area.
3. Polyurea QuickSpray @ 2.5mm applied with Graco XP-2 high pressure spray units.
4. All inlet high abrasion areas were sprayed @ 5mm to provide extra protection.
