Coating of tank roofs, Israel

POLYUREA

Construction Contractor	Bazan Ltd.
Consultant	Orokia Ltd.
Coating Contractor	Polymer Group Ltd.
Project	Tank roofing
Area	300m ² - 8 tank tops
Construction	December 2011
VIP System	QuickSpray Eco

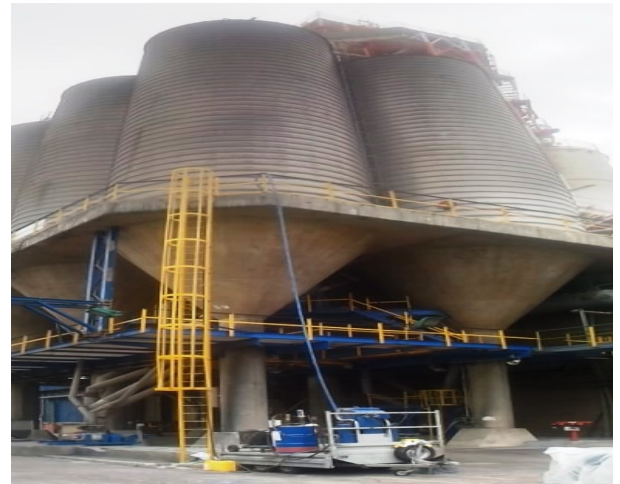
Water was introducing into the polyethylene tanks in this polyolephins plant and caused damage to the material. The contour of the tank top, with many screws and rivets, made its waterproofing difficult task. Bazan Ltd. required a fast curing surface coating with high mechanical abrasion resistance, no VOC contents, no cracking and stable features for restoration and waterproofing for the complete roofs. Application with 1:1 heated, high-pressure, plural component equipment. Pressure of time for fast completion and cost advantages favoured QuickSpray eco from VIP Germany, a Polyurea hybrid 2-part coating system (aromatic) derived from a reaction of isocyanate and amine terminated resin.

- high pressure washing of surface
- grit blasting of steel
- priming
- QuickSpray eco @ 2mm applied

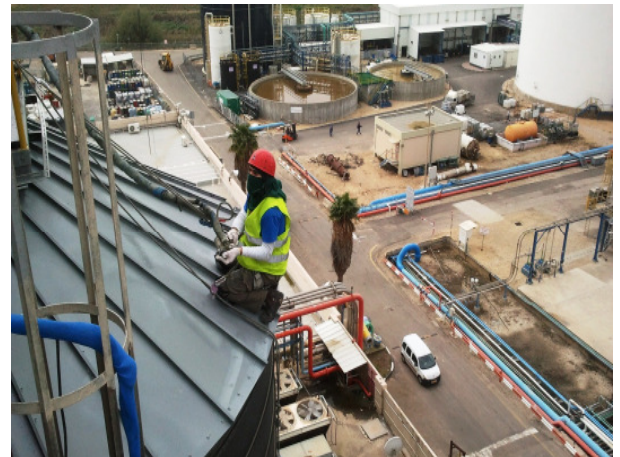
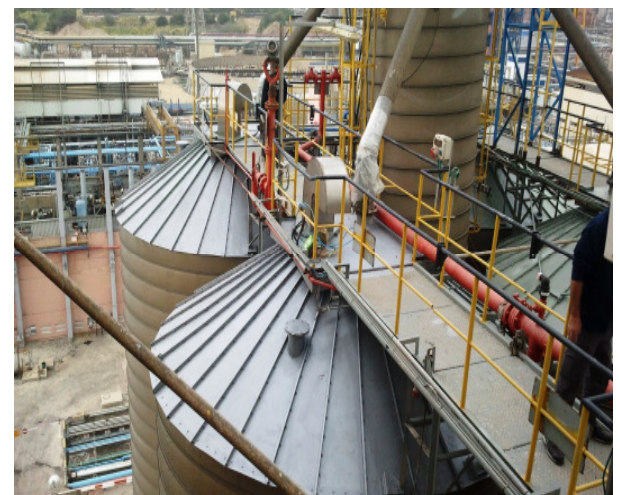
A storm heated Haifa bay area few hours after the job was completed! Heavy rain and strong winds tested the waterproofing ability of the system at the same day it was installed. The maintenance crew was more than satisfied to discover that the precious material inside the tanks remained dry.
