Chalktank at Power Plant, Germany

Client	Vattenfall Europe Generation, Jänschwalde
Consultant	Vattenfall Europe Generation, Peitz
Coating Contractor	RIW GmbH, Köln
Project	Chalktank in the REA Jänschwalde
Surface	approx. 40 m ²
Construction	February 2012
VIP System	QuickFill QuickPrime 1K PU QuickSpray Industrial LSE

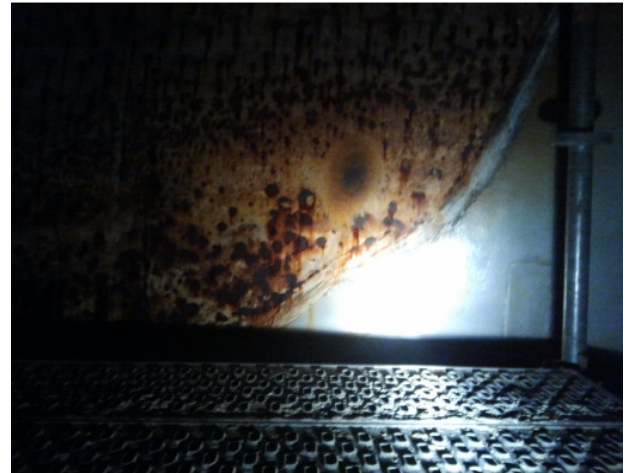
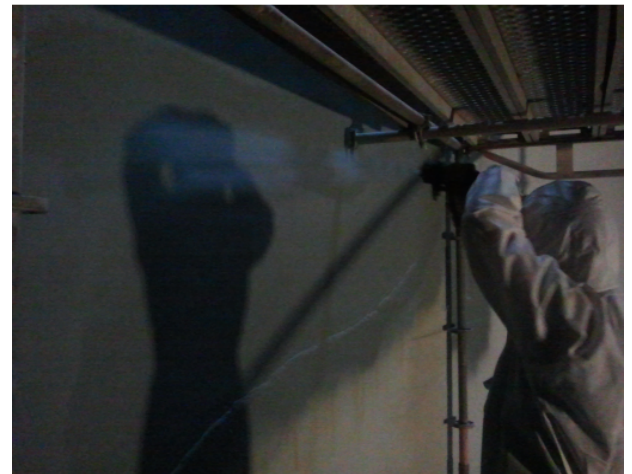
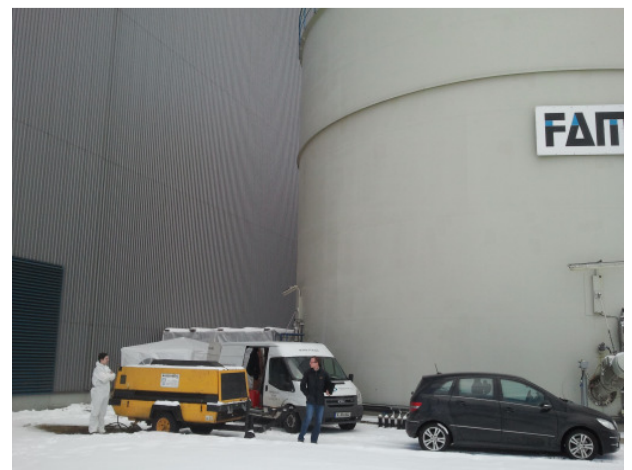
The Vattenfall Europe Generation AG was searching for a new system for sealing and coating tanks on the inside with a high degree of abrasion resistance against the abrasive mixture of chalk and water. On an already coated tank, where the old coating partly became delaminated, the choose to have an area of 40 m² freshly coated to evaluate the new Quickspray Industrial LSE (aromatic). RIW as preferred Applicator was available at short notice to do the repair even in harsh winter conditions. To save time and money the customer choose QuickSpray Industrial LSE (Non stick version with low surface energy), a 100% Polyurea 2-K Hot Spray Coating based on Prepolymer and Polyamine technology.

1. The repair areas were sandblasted as per SA 2 ½ to 3 grade and any imperfections were filled using VIP's QuickFill pure Polyurea repair material 600ml cartridges.
2. To increase adhesion QuickPrime 1K PU was rolled on.
3. After just 30 minutes flash of the aromatic Polyurea was applied at 2-3mms thickness to the primed repair areas on the wall by use of a Graco Reactor HX-P2 hot spray machine.

These steps could be completed successfully in a very short space of time. By using QuickSpray Industrial LSE (aromatic) the work could be carried out even at -5° C outside temperature and -2° C surface temperature. This way the tank could be filled again as planned.
