Magic Life Hotel, Turkey

POLYUREA

Client	Magic Life Hotel Group
Coating Contractor	Arsan Yapi, Antalya, Turkey
Project	Roof Coating Magic Life Hotel, Mugla
Area	2000 m ²
Construction	April 2010
VIP System	QuickSpray Eco

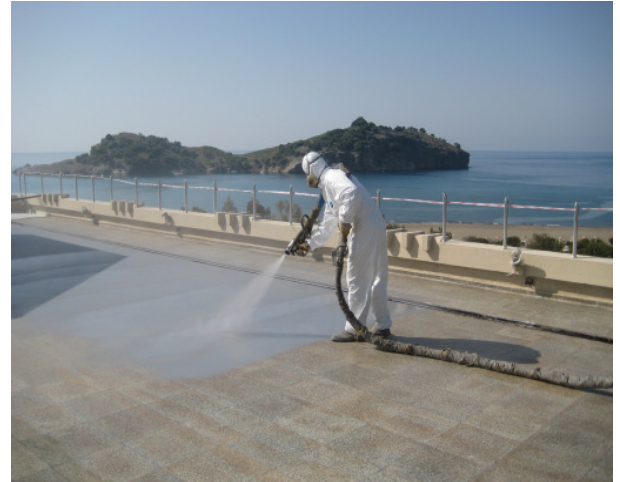
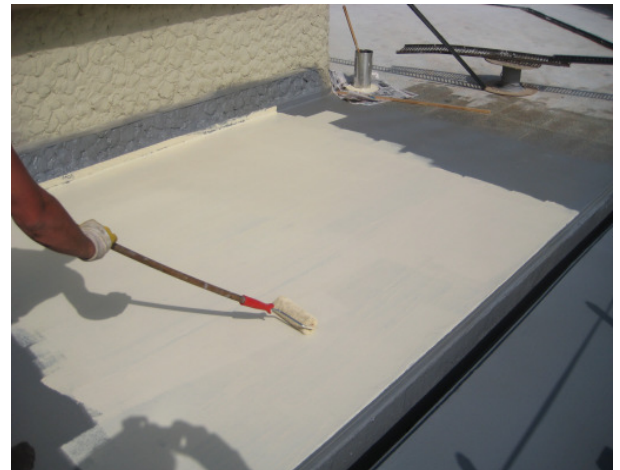
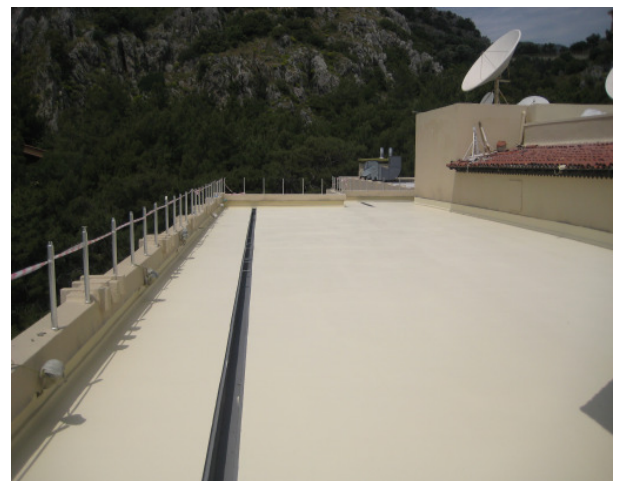
Arsan Yapi required a fast curing surface coating system with high mechanical abrasion resistance, no VOC contents, no cracking and stable features for the restoration and waterproofing for the complete roof of Magic Life Hotel in Mugla, Turkey. Application with 1:1 heated, high-pressure, plural component equipment (Graco XP-2). Pressure of time for fast completion and cost advantages favoured QuickSpray Eco (aromatic), 2-component hybrid-system derived from a reaction of an Isocyanate and a modified Polyurea/Polyurethane resin blend.

1. Concrete was prepared and cleaned of any residues that may have an affect to bonding.
2. Surface was primed and adhesion improved.
3. The aromatic Polyurea QuickSpray applied with heated, high pressure spray equipment.
4. Polyurethane painting applied as a top coat finishing.

The complete process of surface-preparation and application of base coat was successfully completed in 20 days.
